QUARTERLY PROGRESS REPORT
SPUR POWER SYSTEM
CONTRACT AF33(657)-8954
FOR PERIOD ENDING MARCH 31, 1963
PROJECT NUMBER 3145
TASK NUMBER 314511

SY-5396-R4

April 15, 1963

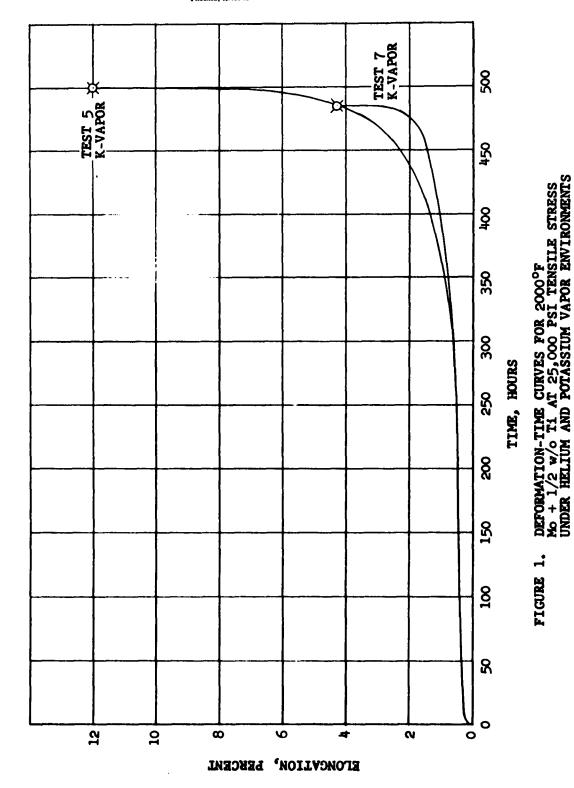
Ten tests are involved in this task; four were completed and two more initiated during the previous quarter. Table I summarizes the conditions and results of all tests to date. Deformation-time curves for tests completed during this quarter are shown in Figures 1 and 2. Figure 3 shows minimum creep rates for the various stresses at 1800°F and 2000°F; Figures 4 and 5 present design curves for stress-relieved Mo + 1/2 w/o Ti at the two temperatures, respectively.

With the exceptions of Test No. 6, which was interrupted twice by furnace failures, and Test No. 7, in which the specimen ruptured near a fillet, all completed tests proceeded normally and data are considered reliable. Tests No. 6 and No. 7 were intended as comparison tests with Test No. 5, which also was interrupted by a furnace failure. As indicated by the time-deformation curve for Test No. 5 on Figure 1,

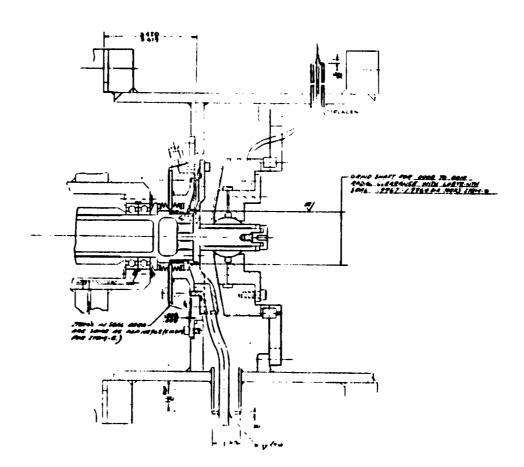
BEARING TEST LOOP BACKUP SEAL FIGURE 11

- (a) A new seal, of the backup design initiated several months earlier, will be installed. This seal is shown in Figure 10, and in the drawing, Figure 11.
- (b) An oil level warning device is being installed in the middle chamber, and an oil sump sight glass is being installed.

- (c) Heaters are being installed on the test bearing (see Figure 11). These heaters will eliminate the possibility of the test bearing section being cooled by the oil above the seal to a temperature below the potassium freezing point. In addition, the capacity of the heaters on the outside of the test section has been increased.
- (d) The potassium line heaters have been modified for improved reliability, and warning lights have been installed on all heaters.
- (e) The potassium lines are 3/8 inch in diameter, having been sized at the time the loop was intended to run rubidium, a substantially more expensive fluid. These tubes are being changed to 1/2-inch diameter wherever possible.

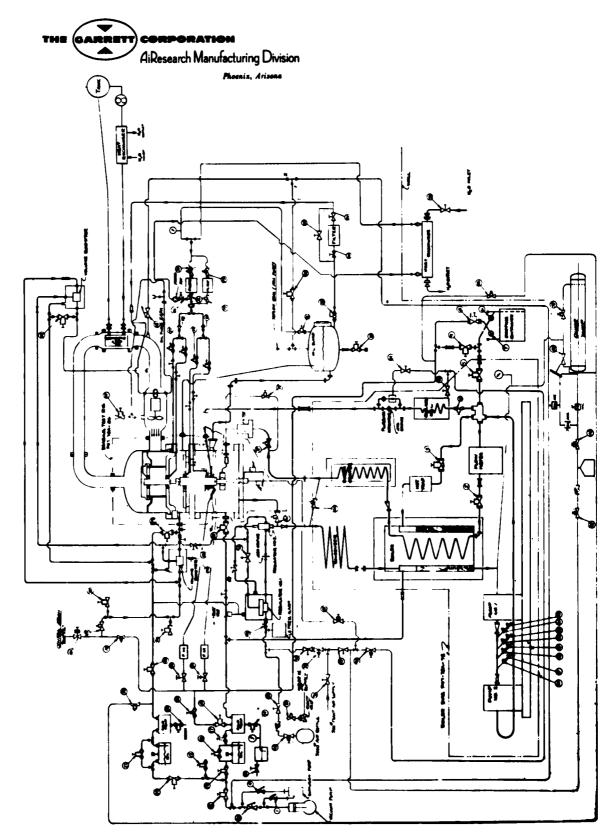
BEARING TEST LOOP SCHEMATIC FIGURE 12 SY-5396-R4 Page 32

It is believed that these changes will eliminate recurrence of the difficulties experienced in this quarter. The most recent loop schematic is shown on Figure 12.

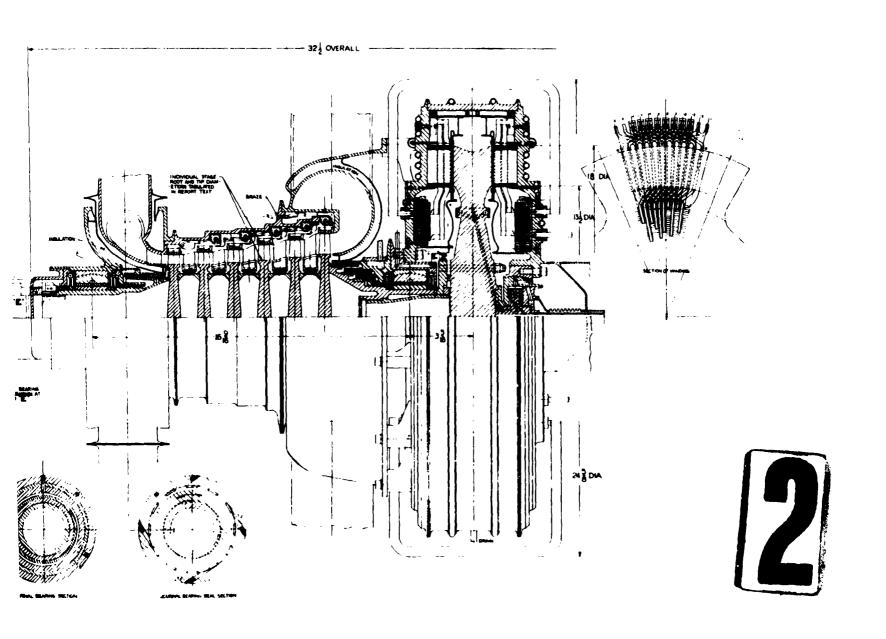
SPUR ALTERNATE TURBOGENERATOR DESIGN FIGURE 15

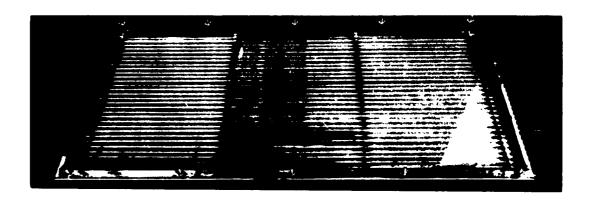
FREON CONDENSER
FIGURE 17

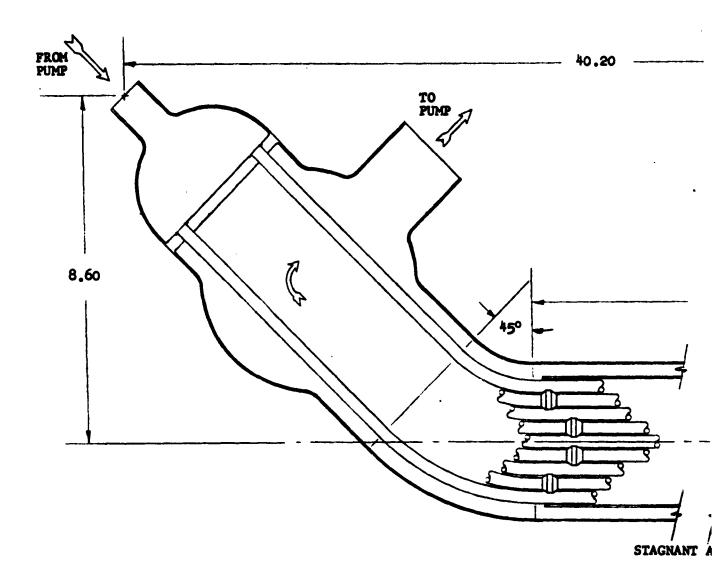
FIGURE 19 STAINLESS STEE RECUPERATOR

Stress analyses of the recuperator and the separator were performed, and an analysis of the effect of reduced-temperature operation on separator performance was made. Layouts of the recuperator and separator are finished, thus completing the remaining task items. The stainless steel recuperator and separator are shown in Figures 19 and 20, respectively.

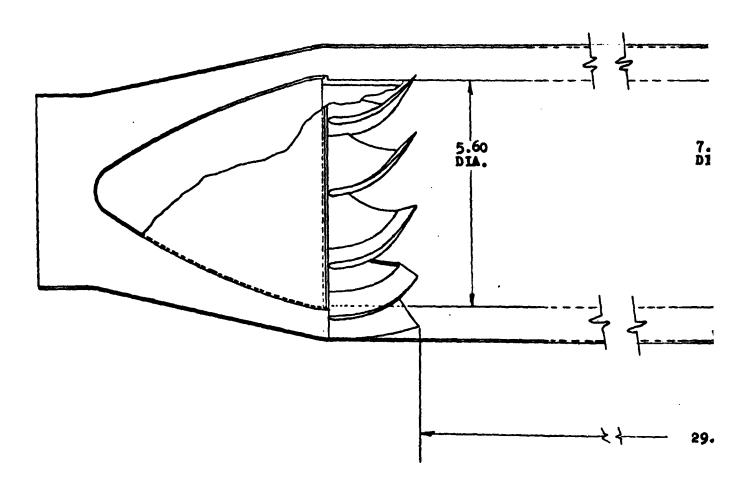
FIGURE 20

STAINLESS STEEL LIQUID-VAPOR SEPARATOR
